# Collagenous socket preservation after atraumatic extraction

The patient, a healthy 57-year-old male with good oral hygiene, presented with multiple deficient old composite restorations and no pain. He was diagnosed with premolar root fracture (tooth 35). After atraumatic extraction, in order to avoid excessive resorption of the alveolar bone, socket preservation was performed using SeptoCone - a high-density collagen cone - providing blood clot stabilization and thus facilitating bone healing. A single implant was placed, showing a stable outcome at 6 years follow-up.

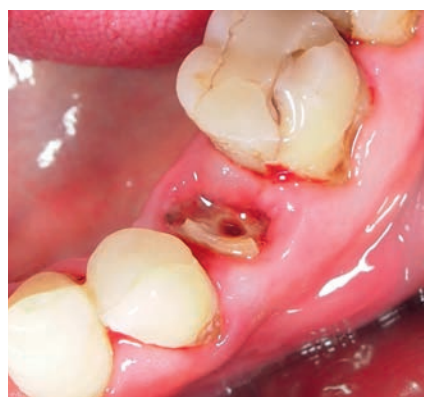
**Fig. 01** - Clinical situation - tooth 35.

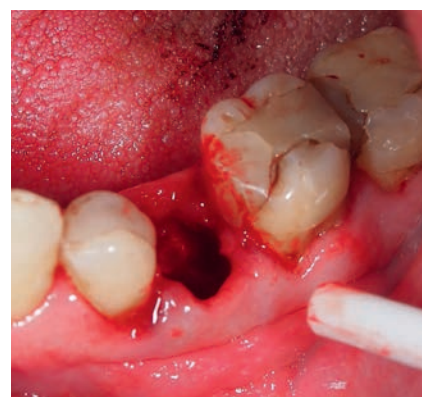
**Fig. 03** - Thorough curettage of the socket is performed after atraumatic extraction.

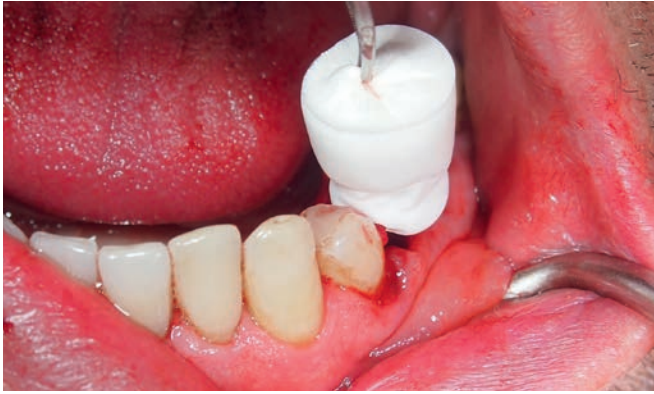
**Fig. 04** - SeptoCone is placed in the empty socket of the single-rooted premolar site. The cone can be gently compressed with the fingers to fit the socket shape.

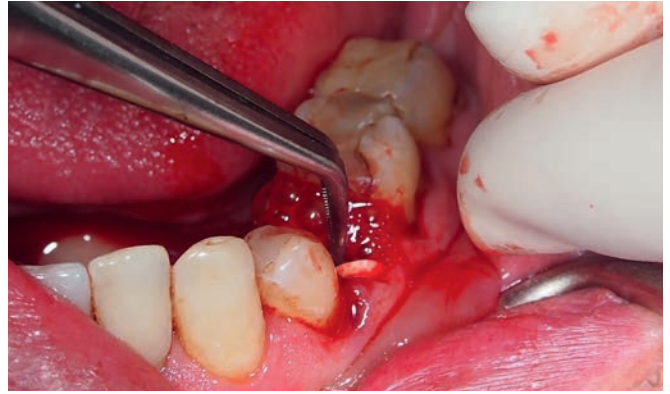
**Fig. 05** - SeptoCone can be safely pushed to the extreme bottom of the root using gentle pressure.

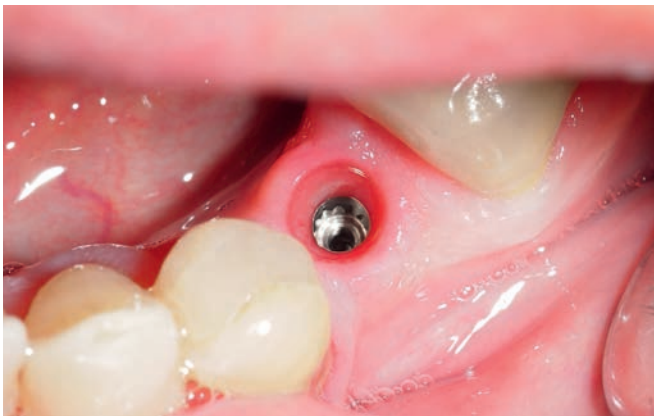
**Fig. 08** - Six months after uneventful hard and soft tissue healing, an implant is placed in the site of tooth 35.
